Think **CRANKCASE EXPLOSIONS** don't happen much anymore?

Think Again

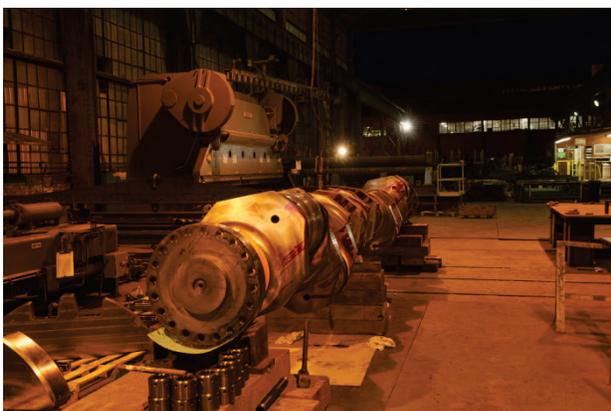
Carnival Splendor broken drive shaft

Board (NTSB) assigned staff to conduct the investigation, while Carnival's own engineers and representatives from both the shipyard and the engine manufacturer also investigated the incident. No definitive conclusions have yet been provided, although the focus remains on one of the diesel generators. Initial findings revealed that diesel engine number five in the aft engine room suffered a split of the crank case and caught fire, damaging the engine control room and the electric cabling.

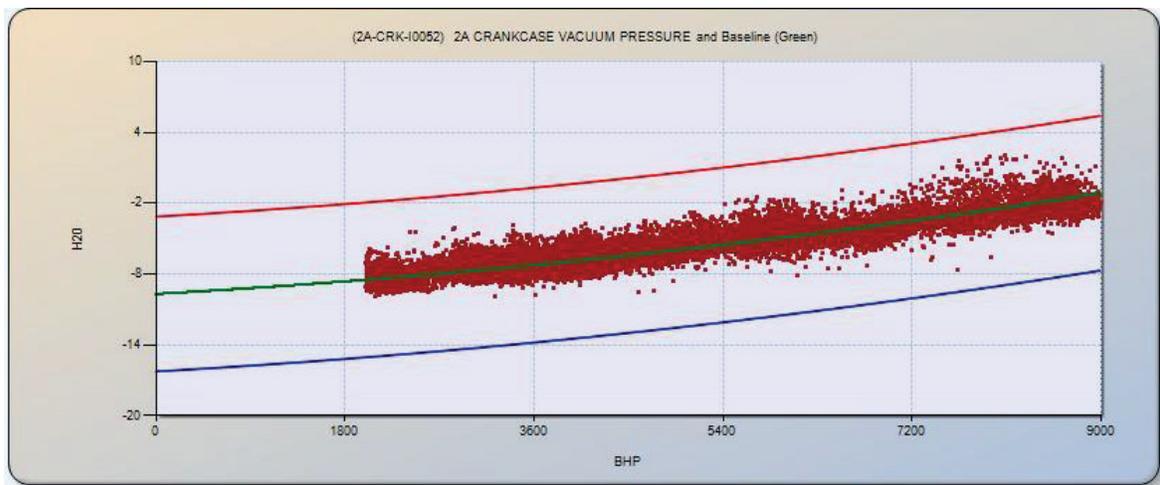
Figure 1 – Crankcase Pressure Baseline Performance across Engine BHP

By comparing operational performance against a known benchmark, such as a baseline performance model, an early warning of a potentially dangerous situation can be obtained, as well as a true indication of the engine's operational health. Figure 1 shows a typical baseline performance model for crankcase pressure as a function of engine load (BHP). The green line represents "healthy" behavior, showing that crankcase pressure should normally increase slightly with engine load. This relationship was derived empirically from actual diesel engine data, plotted as red dots on figure 1. The red and blue lines represent statistical alarm limits, with the region between these lines representing "normal healthy" behavior. A high crankcase pressure is the condition of interest in avoiding crankcase explosions. As figure 1 indicates, crankcase pressure should normally be at a vacuum for a healthy engine condition (i.e. negative pressure readings).

Degrading conditions for any engine can be identified by comparing measured crankcase pressures to the baseline performance model of figure 1, providing as early warning as possible of abnormal performance. For a healthy engine, the plot of crankcase pressure versus engine load should look very similar to figure 1, with all measurements falling within the normal band.

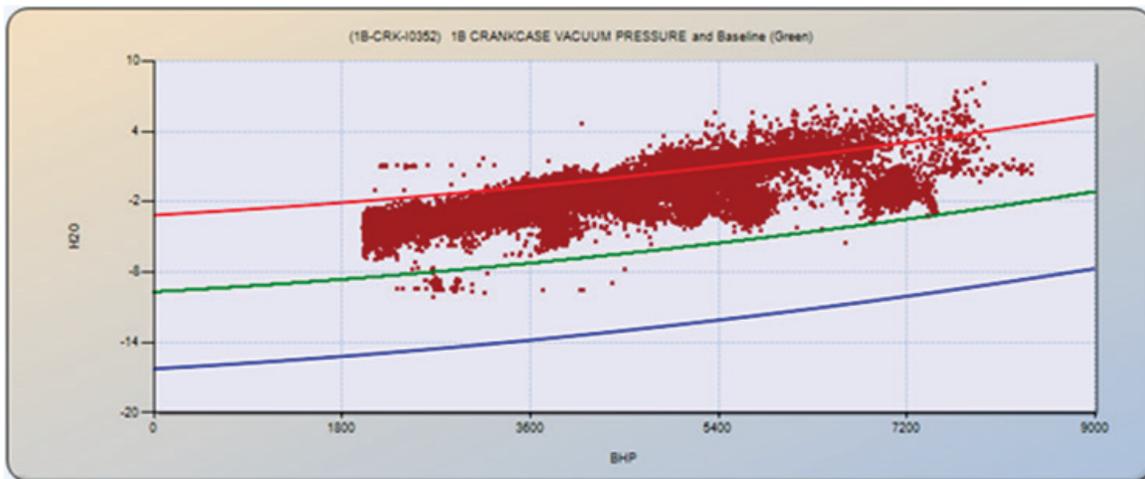
Figure 2 – Developing Risk Conditions for Crankcase Explosion

Figure 2 shows an example of an engine with an abnormally high crankcase pressure and should be cause for immediate investigation into possible reasons. In this case, crankcase pressures sometime exceed the normal values by as much as 11 inches of H²O and should be cause for concern, particularly on a ship without an installed oil mist detector.

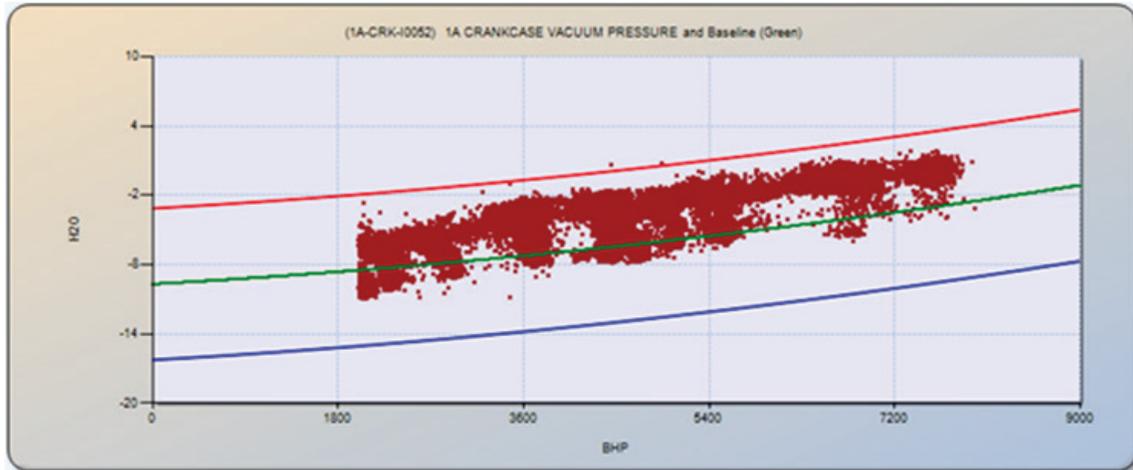
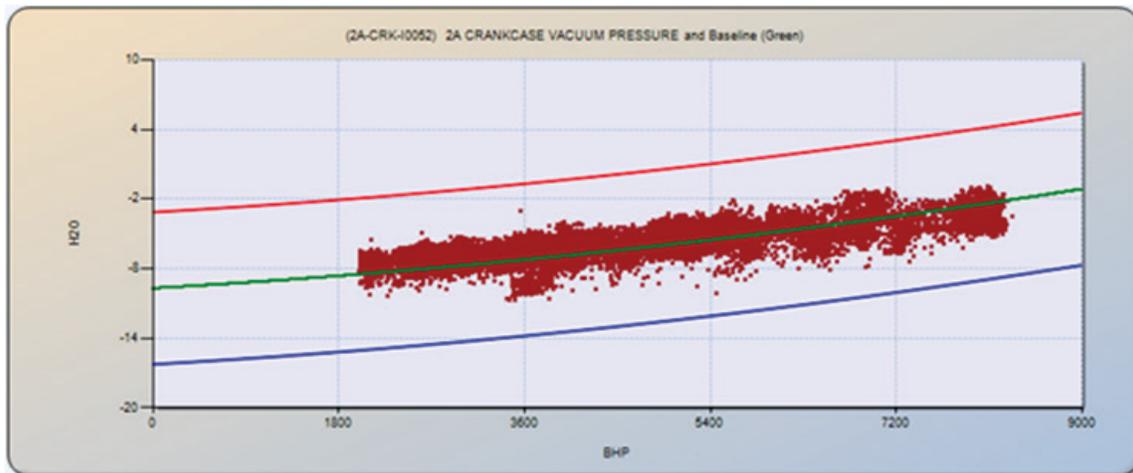
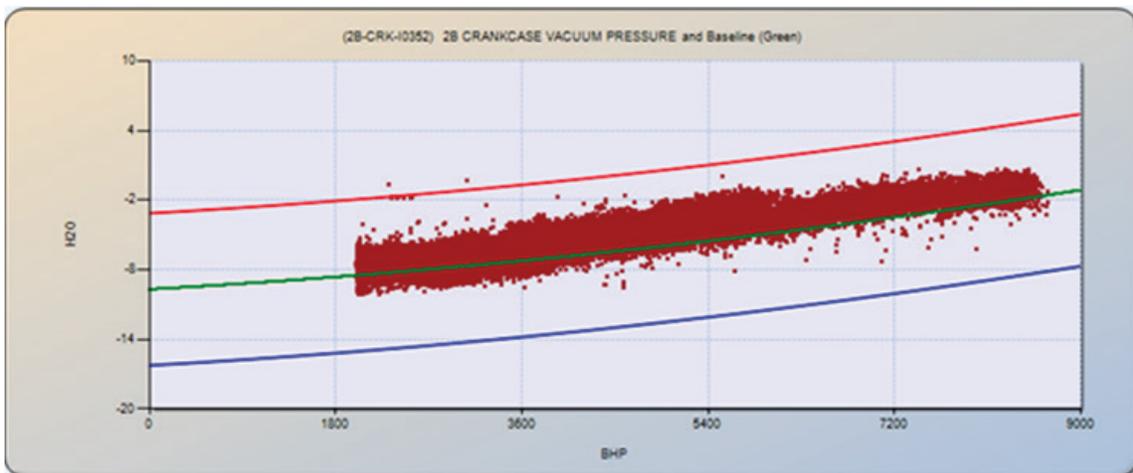
Figure 3 – Engines with Normal Crankcase Pressures

Figure 3 shows similar crankcase pressure behaviors for the other three diesel engines on this particular vessel, all of which appear to be normal
